# Renewal of Historic Materials Using Vacuum Force Technology

*An Improved Method of Structural  
Repair and Restoration of Historic  
Materials*

TECVAC, Inc.  
1998

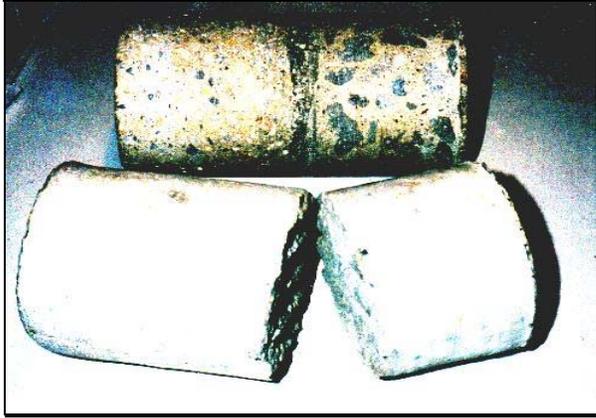
*Before and After TecBond™ Core Samples*

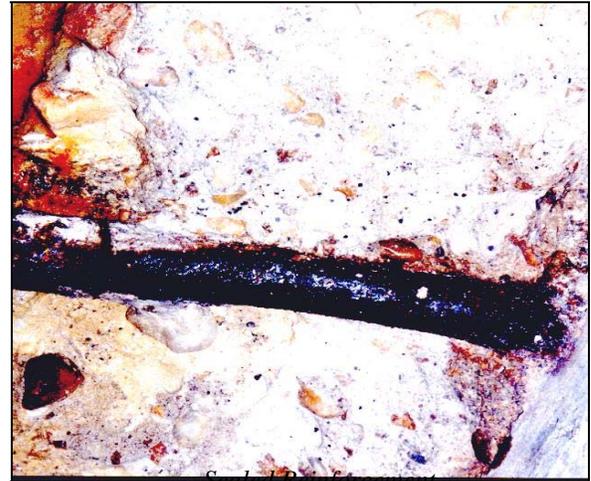
When the fracture or delamination networks or connects with imbedded items, such as reinforcing, the repair resins fill the micro cracking associated with the item and saturate the imbedded item as well. This action does not reverse the current corrosion but seals the imbedded item to stabilize and mitigate further deterioration.

A delaminated topping slab was rebonded with TecBond™. The repairs were performed on a second floor warehouse without displacing the commercial tenants below. Load testing after the repairs confirmed composite stability. Notice the thickened bond line of the topping to the structural slab. Low viscosity repair resins penetrate deep into the repaired materials.

*Sealed Reinforcement*

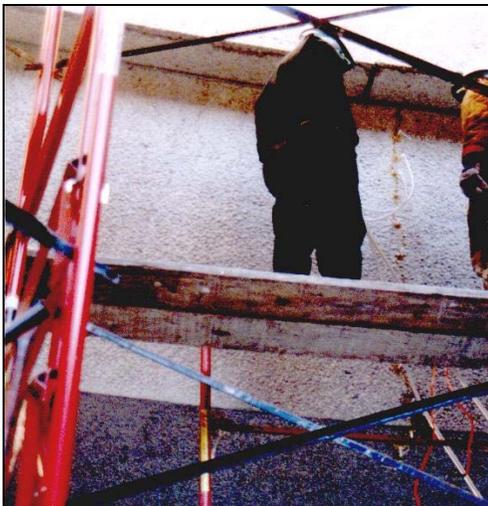
*Before and During*

TECVAC, Inc.'s CleanSet™ application of structural repairs applied to beams constructed of exposed aggregate concrete left no sign of the repair on the surfaces.

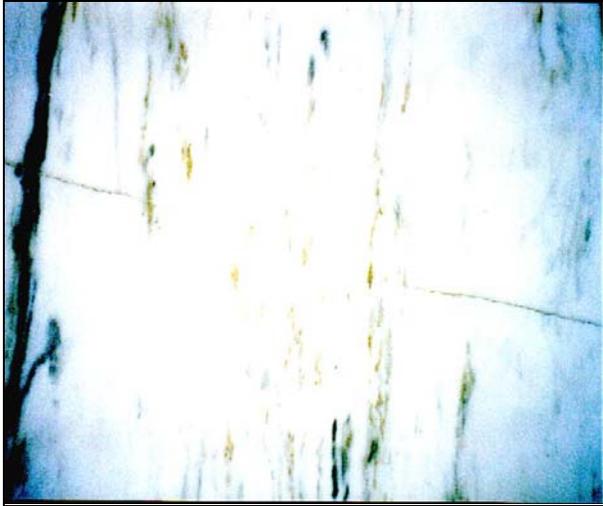
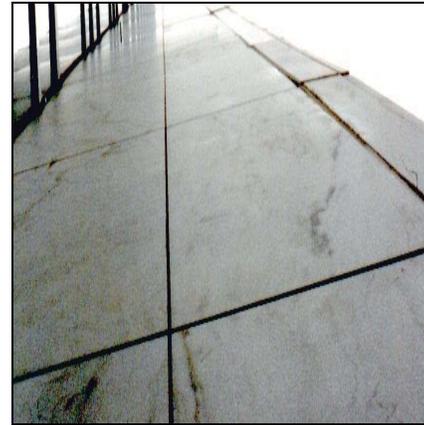
Using the CleanSet<sup>™</sup> Process of vacuum permeation, the repairs can be performed with no telltale evidence left on the surface of the marble.

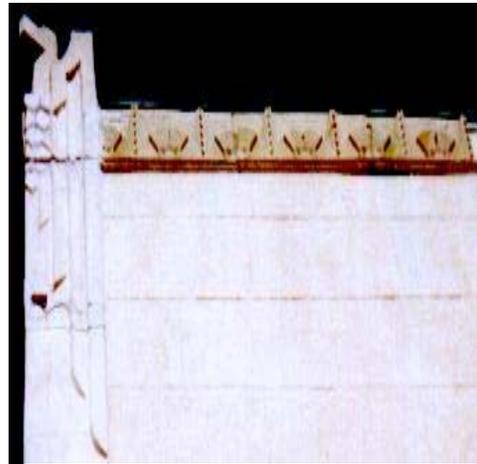
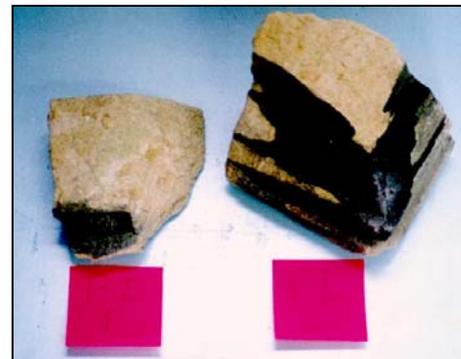
*Stucco finishes can be rebonded with little intrusion.*

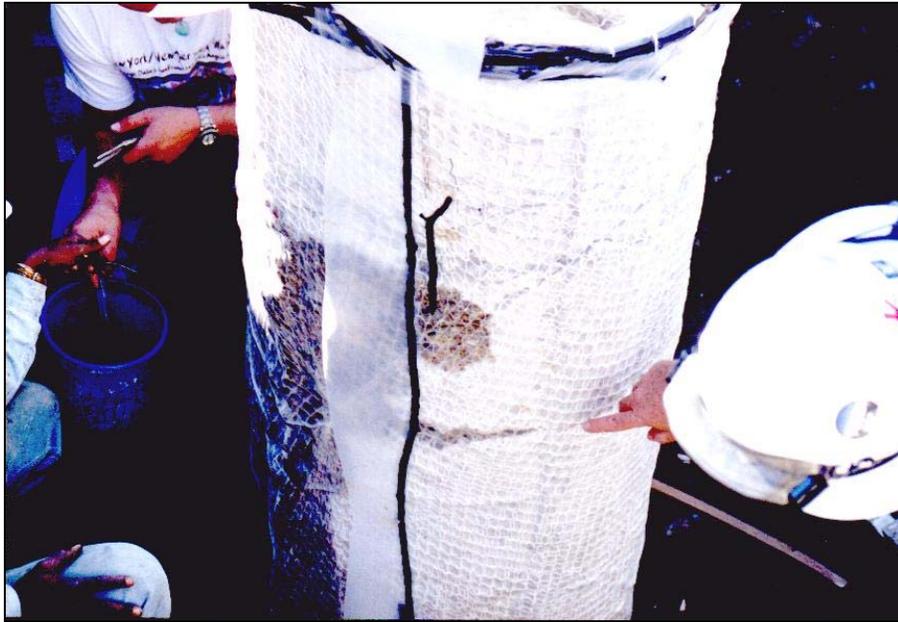
While vacuum is applied to the enclosed system, repair resins penetrated the fractures and move completely across the column. TECVAC, Inc.'s proprietary process allows advance knowledge of crack paths and the ability to ascertain travel. The structural integrity is restored and the surface is waterproofed in the same process.

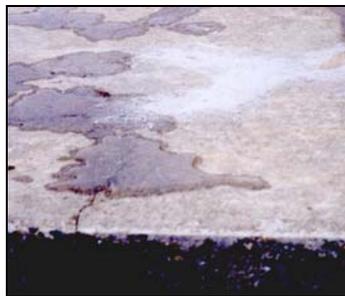
Once cracks are repaired using the TECVAC Processes, there is no further water or moisture penetration of the member.

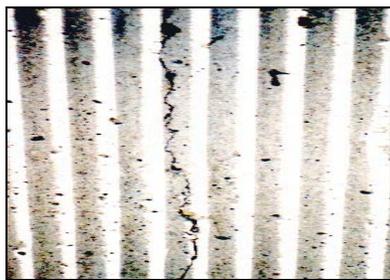
Intricate panels and detailed cornice work can now be repaired with lasting effects. The CleanSet™ Process can set up upon intricate surfaces and produce the structural repair necessary for long life of the member.

*Before*

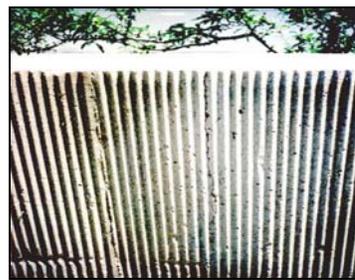
*After*
